Thrust Bearing Cavitation

By Mike Dupuis, Hydro Tech Inc., Canada

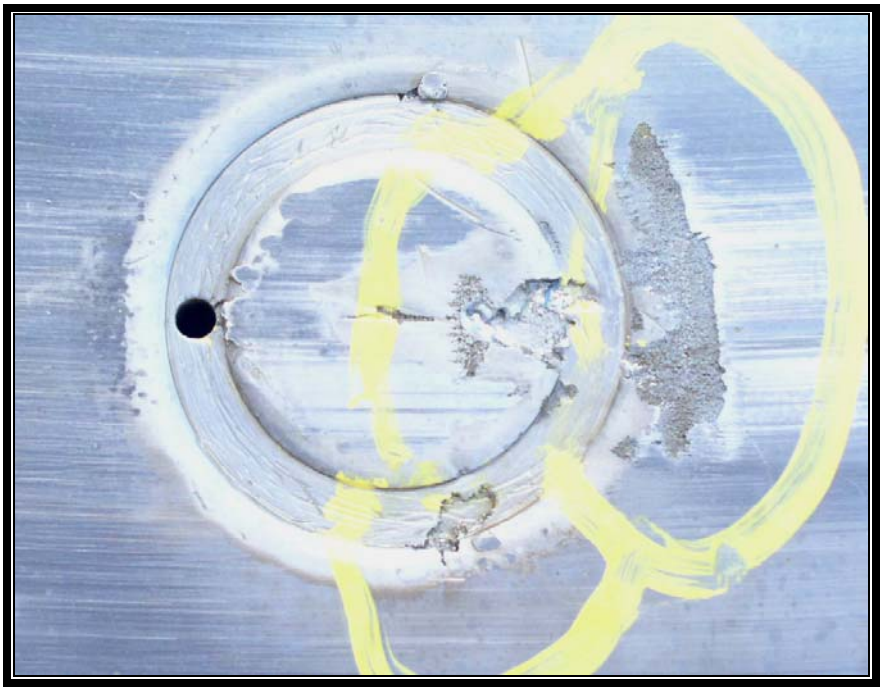
defect in the babbitt. The bearing shoes were reinstalled and operated properly until the turbine runners were upgraded years later. Cavitation was occurring throughout this time; however, the timeline during which significant damage would occur was actually much longer. Thrust bearing cavitation was not significant until after the turbines were upgraded from 135 MW to 170 MW (Photo 1).

Photo 1
High Pressure Lift Port Cavitation

Of further concern, due to increased load on the thrust bearing, the bearing now operates much closer to its ultimate load limits. Photo 1 shows that, in addition to the cavitation, signs of metal-to-metal contact are visible in the presence of slight wiping indications. Small wiping and grooving is evident at the left side of the high pressure oil lift (HPOL) port circle; this indicates that the bearing is overloaded. Prior to the bearing redesign, the generator had to be operated at reduced loading during the warmest time of the year to prevent the bearing from overheating and “wiping”.

The runner plate segments have a gap between them ranging from 0.7mm to 3.2mm. This creates a void in which oil pressure between the stationary bearing pads and the rotating runner plate can disappear. Prior to the turbine upgrade, the thrust bearing operated without incident due to lower average pressures on the bearing. With the increased thrust, the oil film between the babbitt thrust pads and thrust runner plate has decreased, while the average pressure has increased. Because of increasing the pressure drop at the thrust runner plate split, as well as increasing its subsequent effect on the babbitt due to close proximity, the bearing began showing signs of thrust shoe cavitation pitting. This pitting first became evident in the area of the HPOL outlet (Photo1).

As the runner plate passes over the babbitted stationary surface, particularly the HPOL ports, pressure drops dramatically. This creates turbulence causing oil film breaks that disperse dissolved gases and, possibly, oil vapours. Thus, cavitation begins.

The most viable option for addressing the cavitation and overloaded condition of this thrust bearing assembly requires two steps: (1) A new segmented runner plate correctly manufactured, then bolted and keyed together making one complete ring after installation, This would create an improved running surface for the bearing, eliminating spaces for oil pressure to vacate from the bearing surface. (2) Changing

the babbitted bearing pads to high capacity PTFE bearing pads able to provide additional thrust support.

A new bolted and keyed runner plate was designed to prevent cavitation from forming on the bearing pads. PTFE bearing pads were supplied to replace the babbitted bearing pads, thereby providing double the thrust load carrying capabilities.
